Yessine AYED, Guénaël GERMAIN, Amine AMMAR, Benoit FURET - Degradation modes and tool wear mechanisms in finish and rough machining of Ti17 Titanium alloy under high-pressure water jet assistance - Wear - Vol. 305, n°1-2, p.228-237 - 2013

# Degradation modes and tool wear mechanisms in finish and rough machining of Ti17 Titanium alloy under high-pressure water jet assistance

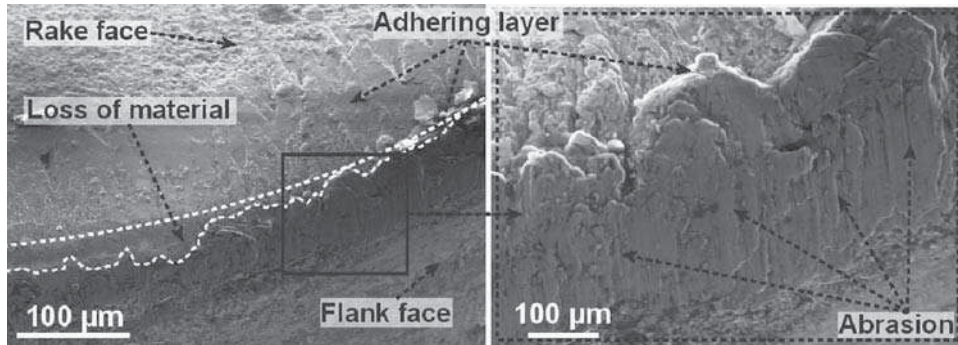
Fig. 4. SEM image of the tool rake/flank face after 20 min of machining in the finishing configuration with conventional lubrication.

Figs. 4–6 show the SEM images of the worn areas on the tool rake face and on the tool flank face for the three tests in the finishing condition. For conventional lubrication, significant flank wear at the nose radius (VBc) is observed. In addition, layers adhering to the rake face are noticed. During machining, the chip rubs on these adherent layers which appear to protect the rake face. However, when the formation of these layers reaches a stagnation level, they become instable and may be peeled-off

leading to wear by adhesion [10]. Alternatively, with HPWJA, a loss of material on the tool rake face and the formation of a crater can be seen. Damage in these areas is more important at a pressure of 250 bars. In this case, it seems that the most important wear mechanism is adhesion accompanied by abrasion and erosion.
